Sharing of Lessons Learnt from a Review of a Surf Life Saving Accident or Incident

Accident Name Club IRB Driver Training – Session One

Accident Date 15th of April 2024

Location Northern Region

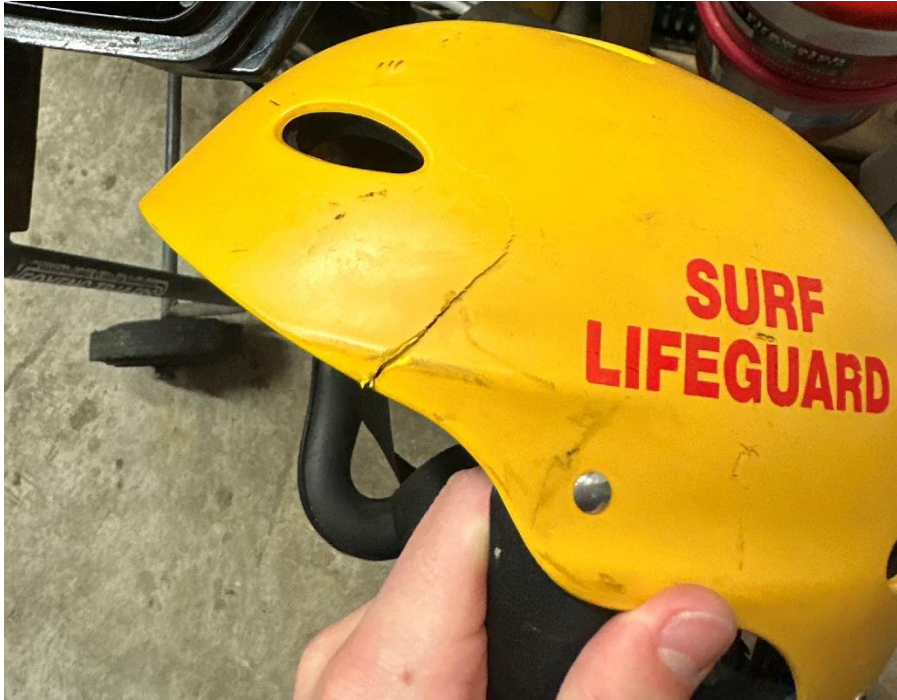
During their training briefing, they were instructed to turn the buoy at ¼-1/2 speed. As they approached the turn from starboard to port, the crewperson lifted himself off the pontoon to transfer his weight into the middle of the boat, intending to make the turn smoother and assist with weight transference. However, as the crew rounded the buoy, he fell overboard from the starboard side of the boat. The trainee driver observed this as the crewperson entered the water head/body first. The trainee driver chose to maintain her speed and complete the turn, but during the maneuverer, the motor leg struck the crewperson's helmet. He surfaced, and the trainee driver completed the turn before returning to recover the crewperson.

The crewperson sustained damage to his helmet and a laceration on the left side of his face.

Damage to the helmet

1. We will strongly reinforce to all SLSNZ Clubs and IRB instructors the necessity of having a qualified IRB Driver present in an IRB when a new trainee IRB Driver is learning.
2. We will issue a reminder to all members to incorporate into their standard practice the checking of the general condition and integrity of PPE. This should occur alongside checking for correct size and fitting.
