SURF LIFE SAVING®
NEW ZEALAND

Sharing of Lessons Learnt from a Review of a Surf Life Saving Accident or Incident

IRB Driver Training mishap

December 2023

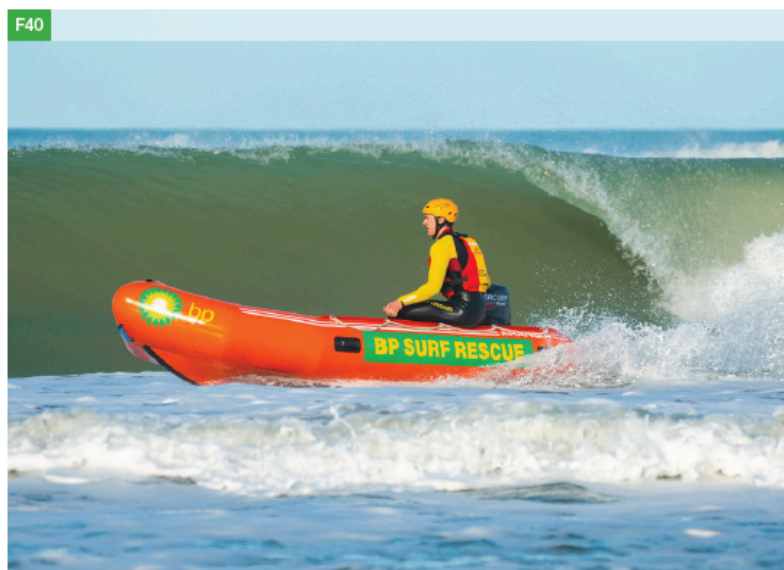
Once back on shore, the immediate focus was on warming up the trainee driver and then washing down the boats. The following day, the IRB underwent inspection by a local mechanic, revealing a malfunction in the throttle return mechanism, which was not functioning at full capacity.

- The SLSC conducted this training without appropriately qualified instructors.
- Although the trainee driver reported checking the throttle return mechanism, he also acknowledged it was not functioning correctly during the pre-use procedure. The motor was still used; however, it should have been removed from operation and clearly marked as non-operational.
- SLSNZ also requires a second IRB to be ready when any IRB training is carried out. The Training NSOP was not followed.
- The trainee IRB driver reported being 600m offshore while operating the IRB solo. However, SLSNZ does not endorse solo driving practices. Instead, the focus has shifted towards implementing safe procedures for crew retrieval if they fall out of the IRB, or simply ensuring a safe return to shore.

The IRB throttle mechanism was repaired at the local service center and adjusted to ensure it became fully operational again.

- When we deviate from normal Standing Operating Procedures, we are more likely to encounter challenges.
- Not withdrawing equipment once it is found to be not fully operational. (This motor should have been tagged and clearly identified as non-operational until it had been checked and repaired).
- Not following our training NSOPs around Instructors.
- We do not need to go a long way offshore at any time during training.
