## Sharing of Lessons Learnt from a Review of a Surf Life Saving Accident or Incident

<b>Accident Name</b>	IRB Crewperson Injury
<b>Accident Date</b>	4th of September 2022
<b>Location</b>	Canterbury
<b>Description of the accident/incident</b>	
<p>In early September as our volunteer surf lifeguards started returning to training and jumping back into the IRB we had a surf lifeguard taking part in an organised IRB crewpersons training session with their SLSC on their home beach. This member was a trainee crewperson with an experienced IRB driver when they approached a small ½ metre broken wave, the crewperson’s right foot slipped from where it was resting on the fuel bladder, slipping back and becoming wedged between the side pontoon and the floorboard. The driver wasn’t aware of where the crewperson’s right foot was and it appears they landed after going over the wave and her ankle has become twisted and trapped between the floorboard and the side pontoon.</p>	
<b>Outcome</b>	
<p>The crewperson suffered a fracture to her fibula. (A broken ankle).</p>

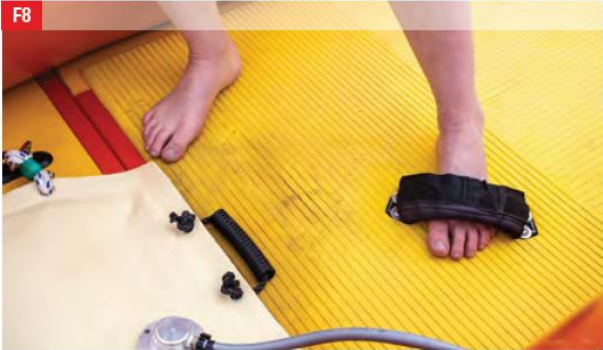
<p><b>IRB Instruction Manual – Page 47</b></p>

<b>Causes (Immediate, Underlying, Root Cause)</b>	
<p>The crewperson wasn’t specifically instructed as to where to put her right foot before going out onto the water in the IRB.</p> <p>The crewperson’s right ankle got caught in an awkward position and with the force of going over a wave something had to give and sadly this was the crewperson’s right ankle.</p>	
<b>Relevant Photo’s</b>	
<p>Although there will be some variations this is the preferred right-foot positioning</p>

- On Thursday the 8<sup>th</sup> of September a Safety Alert was sent out to all Surf Lifesaving Club's, IRB Instructors, and Examiners that they must be very clear with trainees about the preferred safe IRB Crewing Position along with appropriate pages from the SLSNZ IRB Instruction Manual (as per the photo above).
- Continue to progress with urgency the in safe technique videos
